# Images and Analysis of a PCB Failure

The information on this page presents an analysis of a PCB when using a Huntron Tracker system for troubleshooting to the component level. Sometimes when analyzing signatures sampled from bad PCBs it is important to note "what is not there" as well as "what is there". This can tell you much about the nature of the actual failure.

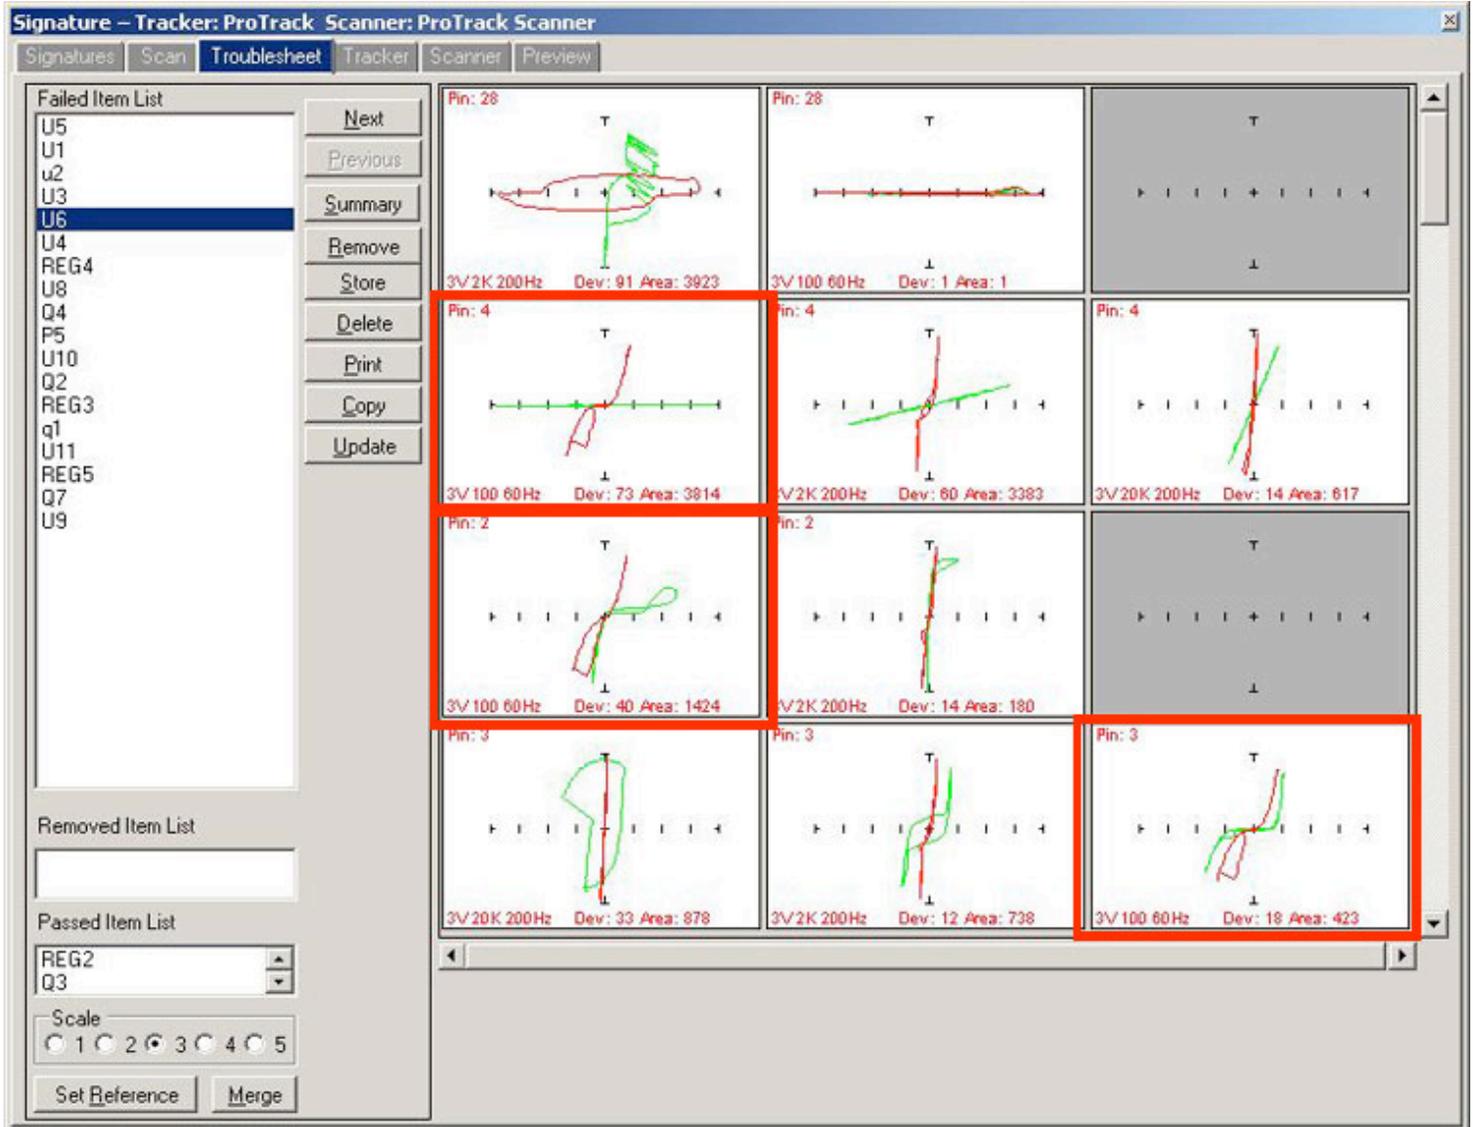
The key signatures in this analysis are indicated with red boxes. Note that the red signatures are very much the same where the green signatures for those same pins are very different from each other. The only way these signature differences are possible is by a very low resistance short circuit connecting the pins together. Note that pin 4 normally indicates a resistive signature (the angled signature in green; very likely caused by a connected pull-down resistor) whereas the red signature indicates that the normally connected resistance is being bypassed. In Signature Analysis troubleshooting, any resistive change is worth investigating.

The Troubleshoot created from this TOP side only test had several components that indicated signature differences and most of these failures were caused by signature instability. Further refinement of the test ranges would reduce the Troubleshoot to fewer components. The signatures from pins 2, 3 and 4 on U6 were caused by a real failure and not signature instability (unlike pin 28).

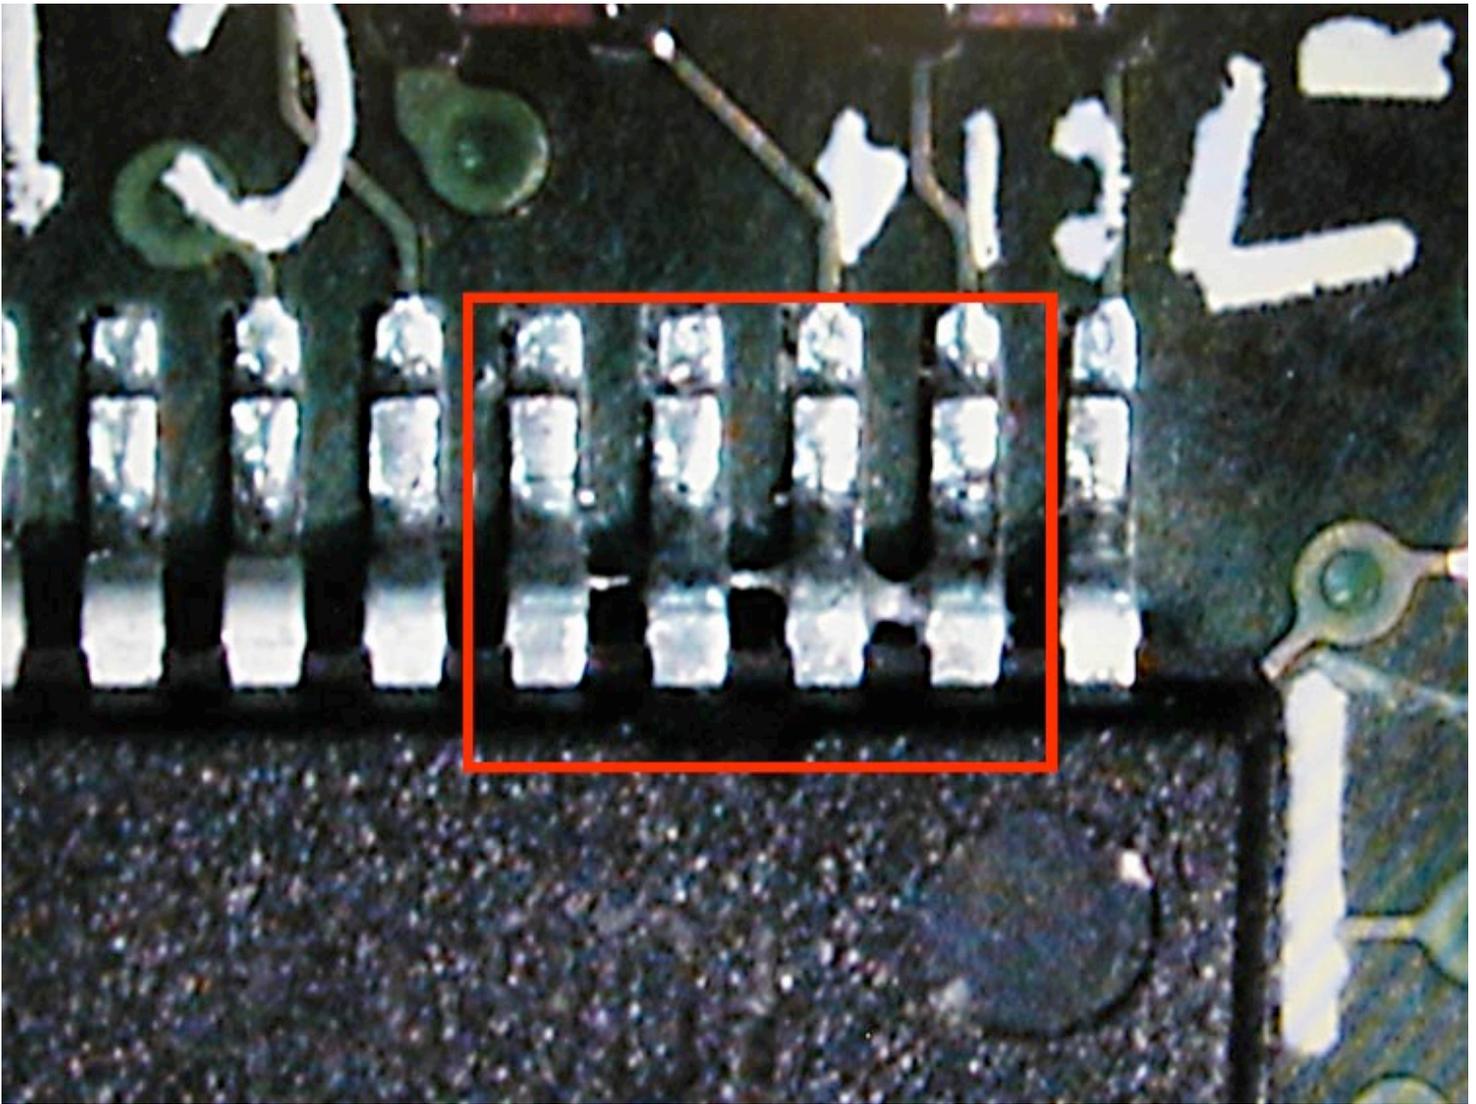
Further analysis with a high powered video camera of the suspect pins (see image below) verified the actual problem of pins shorted together by solder. This appears to be production process error.

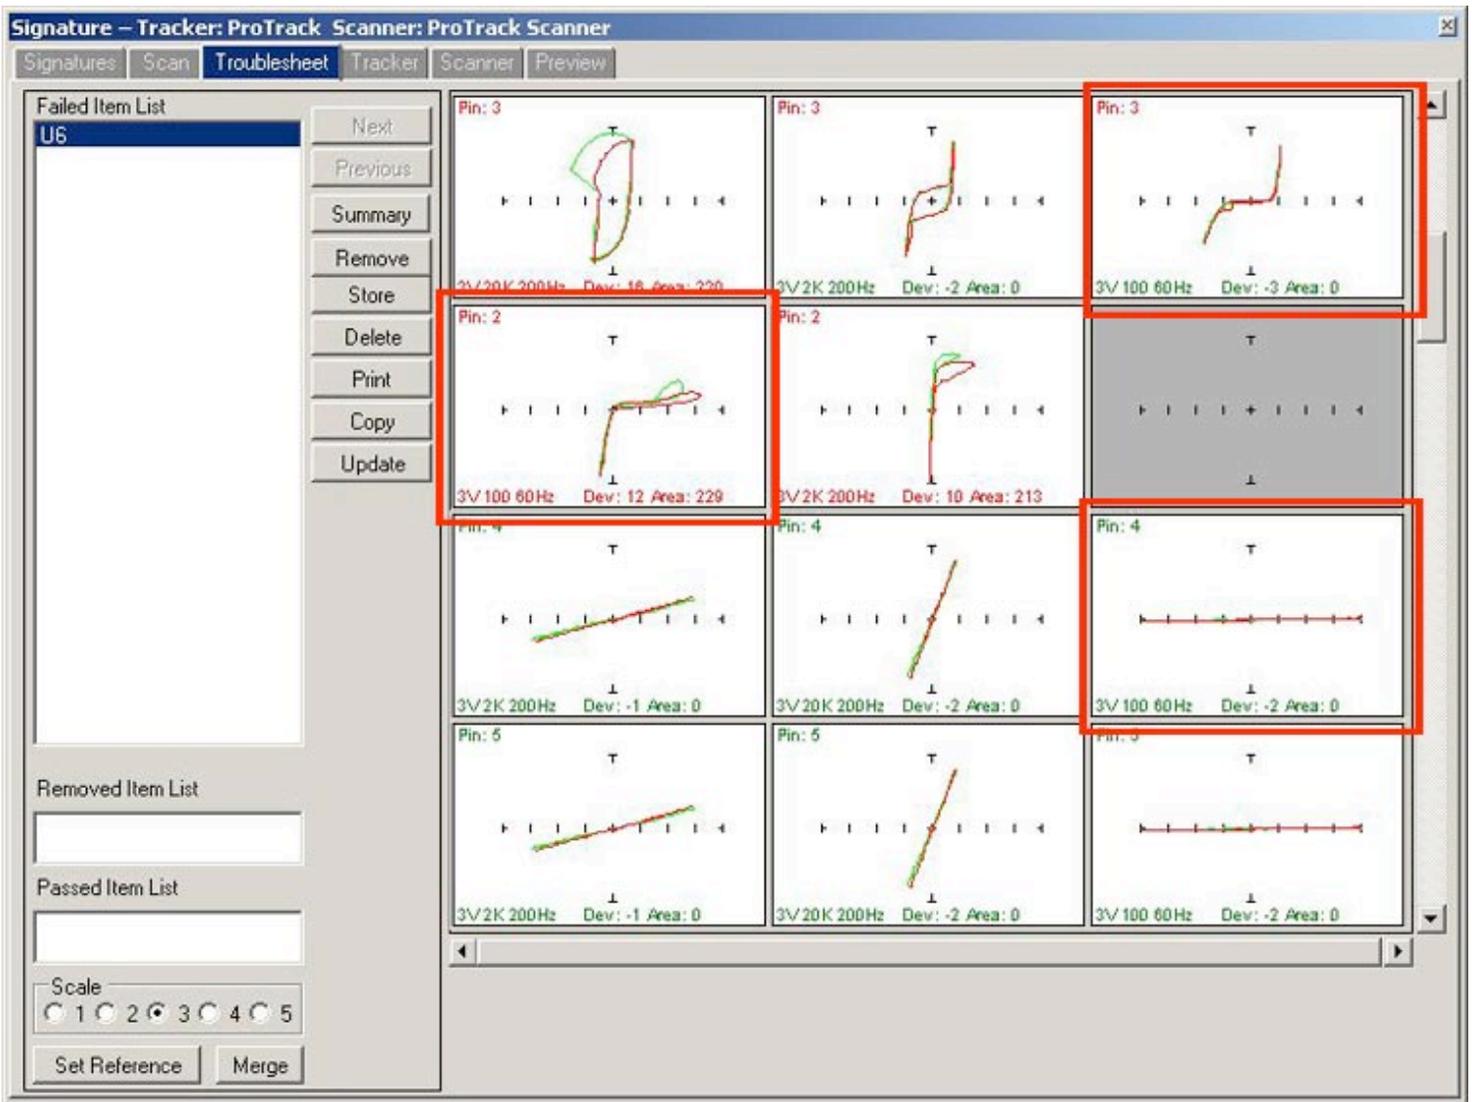
The signatures that indicated the failure in the previous test are highlighted in the image. The analysis shows that the signatures are (for the most part) passing the comparison with the stored reference signatures. Removing the solder shorts from the IC pins effectively fixed the problem indicated by the original test. Once again, additional refinement of the test would result in more stable signatures and further reducing the size of the Troubleshoot.

At request of the customer, the solder shorts from U6 were removed and the component retested with the Huntron ProTrack and Access Prober. The resulting signatures for the test are displayed below.
